HOME REPORT

14 NIMMO AVENUE
PERTH
PH1 2PX

Energy Performance Certificate (EPC)

14 NIMMO AVENUE, PERTH, PH1 2PX

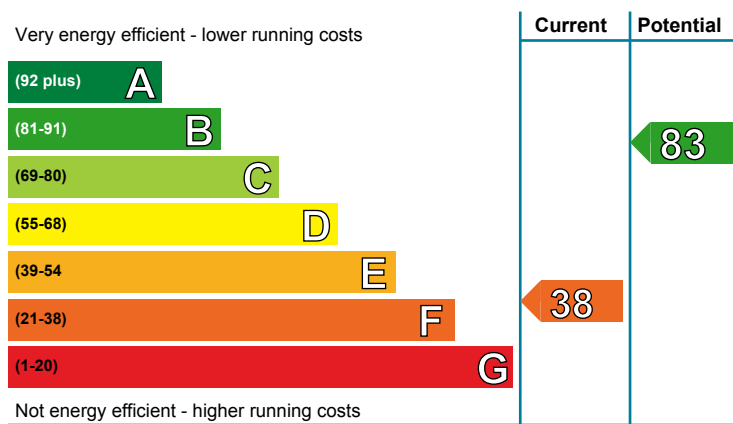
Energy Efficiency Rating

This graph shows the current efficiency of your home, taking into account both energy efficiency and fuel costs. The higher this rating, the lower your fuel bills are likely to be.

Your current rating is **band F (38)**. The average rating for EPCs in Scotland is **band D (61)**.

The potential rating shows the effect of undertaking all of the improvement measures listed within your recommendations report.

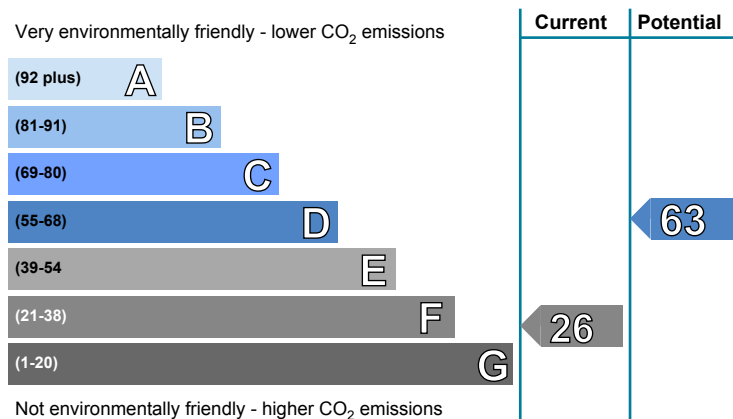
Environmental Impact (CO₂) Rating

This graph shows the effect of your home on the environment in terms of carbon dioxide (CO₂) emissions. The higher the rating, the less impact it has on the environment.

Your current rating is **band F (26)**. The average rating for EPCs in Scotland is **band D (59)**.

The potential rating shows the effect of undertaking all of the improvement measures listed within your recommendations report.
