HOME
report

SINGLE SURVEY
ENERGY REPORT
PROPERTY QUESTIONNAIRE
VALUATION REPORT

Single Survey

Property address	Ground Floor Right, 228 Victoria Road, Aberdeen, AB11 9NR
-------------------------	--

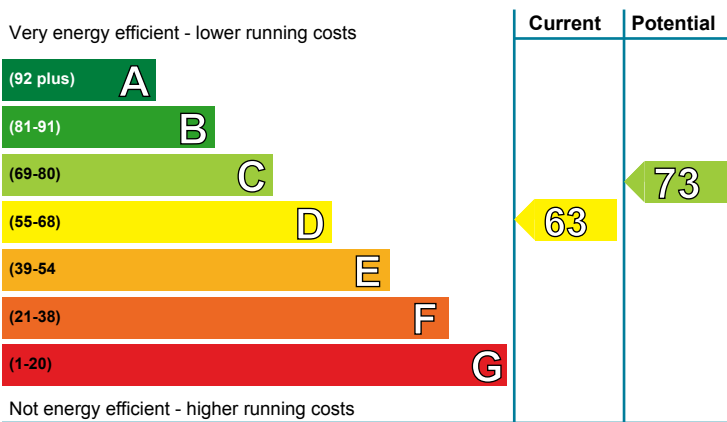
Energy Efficiency Rating

This graph shows the current efficiency of your home, taking into account both energy efficiency and fuel costs. The higher this rating, the lower your fuel bills are likely to be.

Your current rating is **band D (63)**. The average rating for EPCs in Scotland is **band D (61)**.

The potential rating shows the effect of undertaking all of the improvement measures listed within your recommendations report.
