Home Report

5 Cassillis Street
Ayr
KA7 1DN

single survey

Property address	5 Cassillis Street Ayr KA7 1DN
Customer	Mrs Nancy McNeil
Prepared by	Graham + Sibbald LLP

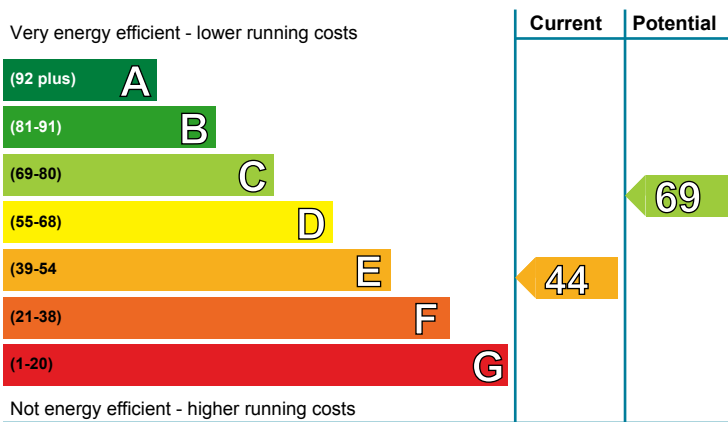
Energy Efficiency Rating

This graph shows the current efficiency of your home, taking into account both energy efficiency and fuel costs. The higher this rating, the lower your fuel bills are likely to be.

Your current rating is **band E (44)**. The average rating for EPCs in Scotland is **band D (61)**.

The potential rating shows the effect of undertaking all of the improvement measures listed within your recommendations report.

Estimated energy costs for your home for 3 years*	£24,204	See your recommendations report for more information
Over 3 years you could save*	£8,934
