# Home Report

49 Auchendoon Crescent  
Ayr  
KA7 4AT

# single survey

## survey report on:

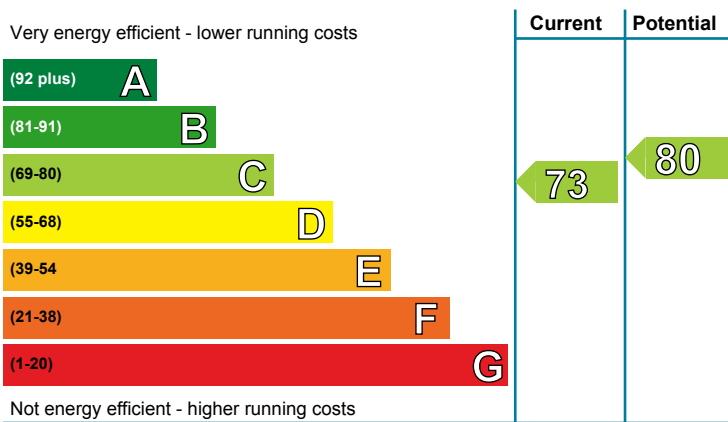
## Energy Efficiency Rating

This graph shows the current efficiency of your home, taking into account both energy efficiency and fuel costs. The higher this rating, the lower your fuel bills are likely to be.

Your current rating is **band C (73)**. The average rating for EPCs in Scotland is **band D (61)**.

The potential rating shows the effect of undertaking all of the improvement measures listed within your recommendations report.

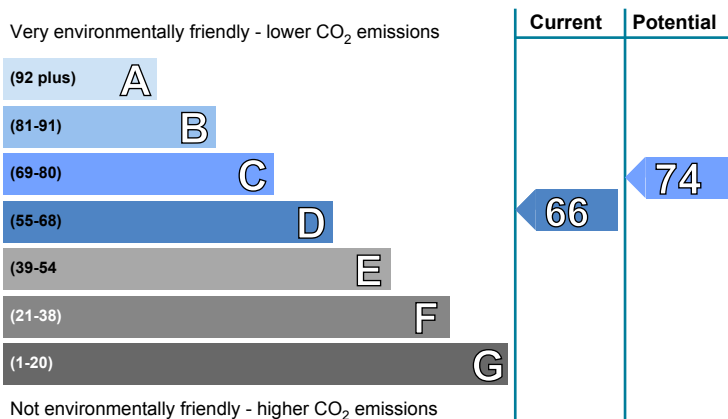
## Environmental Impact (CO<sub>2</sub>) Rating

This graph shows the effect of your home on the environment in terms of carbon dioxide (CO<sub>2</sub>) emissions. The higher the rating, the less impact it has on the environment.
