HOME
report

SINGLE SURVEY
ENERGY REPORT
PROPERTY QUESTIONNAIRE
VALUATION REPORT

Single Survey

Property address	25 Lochpots Road, Fraserburgh, AB43 9NH
-------------------------	---

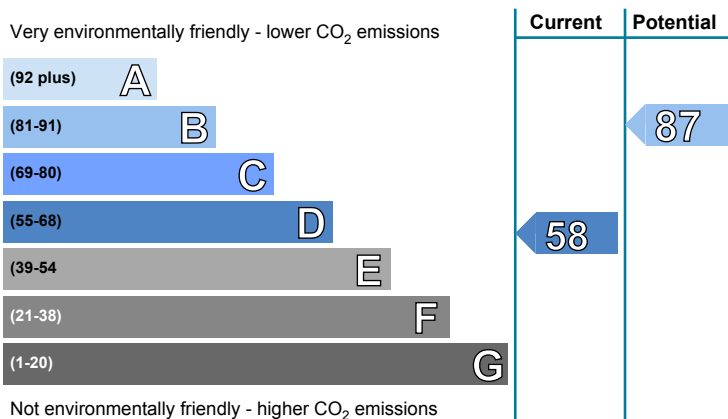
Environmental Impact (CO₂) Rating

This graph shows the effect of your home on the environment in terms of carbon dioxide (CO₂) emissions. The higher the rating, the less impact it has on the environment.
