Home Report

45 Woodstock Street
Kilmarnock
KA1 2AT

single survey

survey report on:

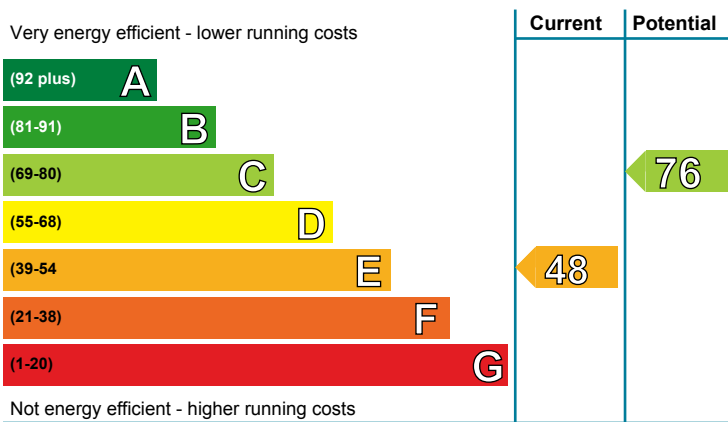
Energy Efficiency Rating

This graph shows the current efficiency of your home, taking into account both energy efficiency and fuel costs. The higher this rating, the lower your fuel bills are likely to be.

Your current rating is **band E (48)**. The average rating for EPCs in Scotland is **band D (61)**.

The potential rating shows the effect of undertaking all of the improvement measures listed within your recommendations report.

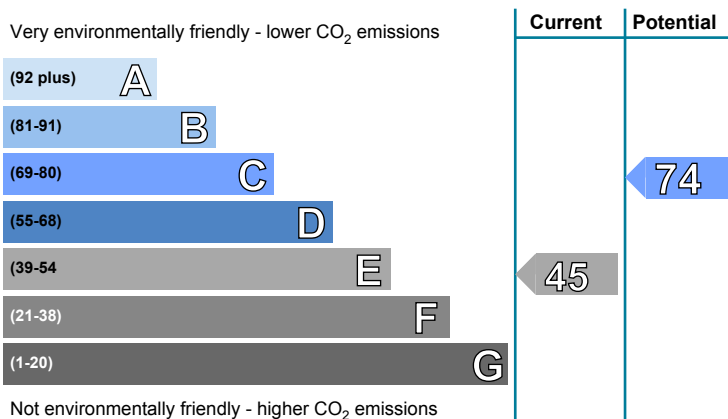
Environmental Impact (CO₂) Rating

This graph shows the effect of your home on the environment in terms of carbon dioxide (CO₂) emissions. The higher the rating, the less impact it has on the environment.
