# Home Report

# Scottish Single Survey

<b>Property address</b>	11 Kidd Street Kirkcaldy KY1 2ED
<b>Customer</b>	FIFE HOME IMPROVEMENT LTD
<b>Customer address</b>	11 Kidd Street Kirkcaldy KY1 2ED
<b>Prepared by</b>	Shepherd Chartered Surveyors
<b>Date of inspection</b>	02/02/2024

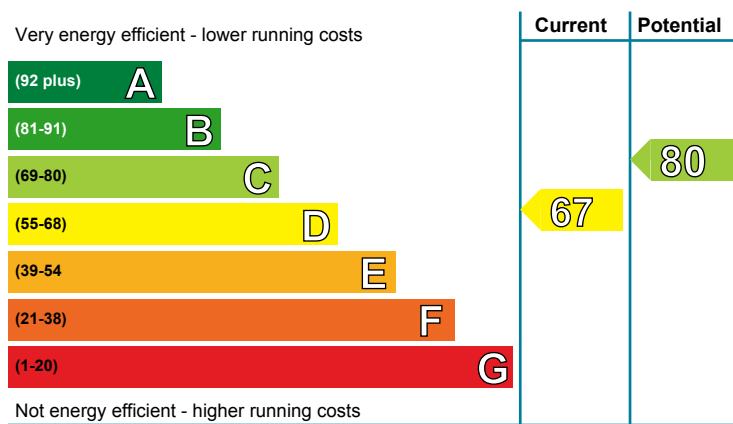
## Energy Efficiency Rating

This graph shows the current efficiency of your home, taking into account both energy efficiency and fuel costs. The higher this rating, the lower your fuel bills are likely to be.

Your current rating is **band D (67)**. The average rating for EPCs in Scotland is **band D (61)**.

The potential rating shows the effect of undertaking all of the improvement measures listed within your recommendations report.
