HOME
report

SINGLE SURVEY
ENERGY REPORT
PROPERTY QUESTIONNAIRE
VALUATION REPORT

Survey report on:

Property Address	11 Tain Place Kirkcaldy KY2 6FX
Customer	Mr A Harley
Date of Inspection	05/01/2024
Prepared by	Stuart MacGregor Harvey Donaldson & Gibson Chartered Surveyors

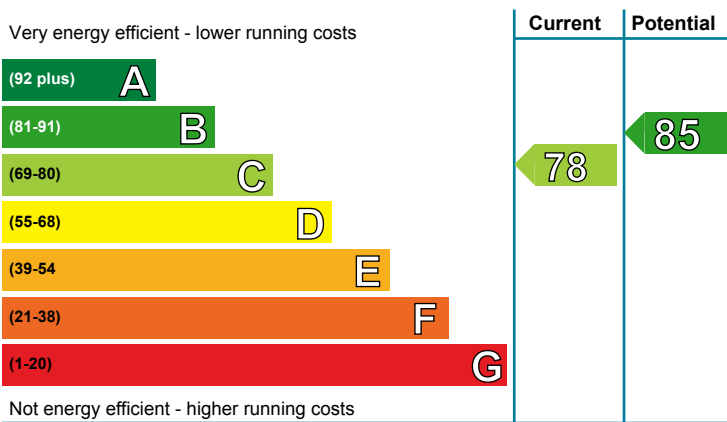
Energy Efficiency Rating

This graph shows the current efficiency of your home, taking into account both energy efficiency and fuel costs. The higher this rating, the lower your fuel bills are likely to be.

Your current rating is **band C (78)**. The average rating for EPCs in Scotland is **band D (61)**.

The potential rating shows the effect of undertaking all of the improvement measures listed within your recommendations report.
