HOME REPORT

29 DEAS WHARF
KIRKCALDY
KY1 1JJ

Dwelling type: Mid-floor flat
Date of assessment: 19 June 2023
Date of certificate: 24 July 2023
Total floor area: 72 m²
Primary Energy Indicator: 133 kWh/m²/year

Reference number: 1817-7226-4000-0801-4296
Type of assessment: RdSAP, existing dwelling
Approved Organisation: Elmhurst
Main heating and fuel: Boiler and radiators, mains gas

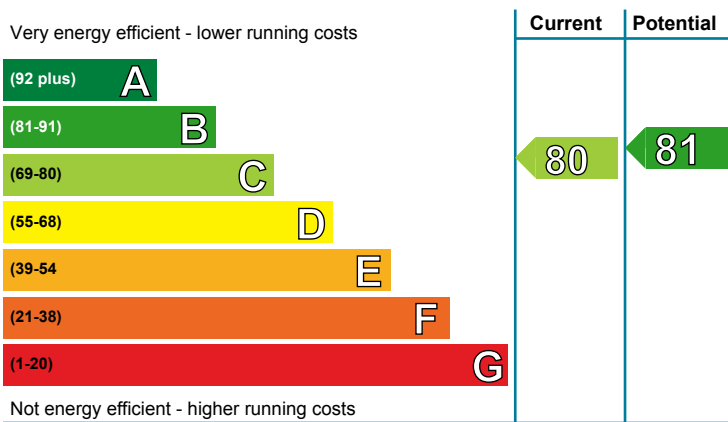
Energy Efficiency Rating

This graph shows the current efficiency of your home, taking into account both energy efficiency and fuel costs. The higher this rating, the lower your fuel bills are likely to be.

Your current rating is **band C (80)**. The average rating for EPCs in Scotland is **band D (61)**.

The potential rating shows the effect of undertaking all of the improvement measures listed within your recommendations report.

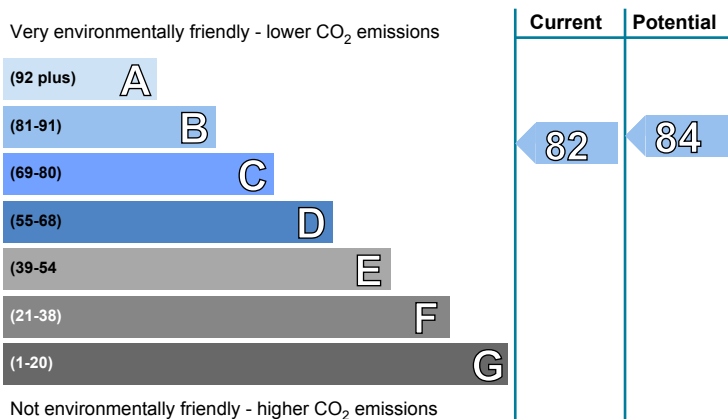
Environmental Impact (CO₂) Rating

This graph shows the effect of your home on the environment in terms of carbon dioxide (CO₂) emissions. The higher the rating, the less impact it has on the environment.

Your current rating is **band B (82)**. The average rating for EPCs in Scotland is **band D (59)**.

The potential rating shows the effect of undertaking all of the improvement measures listed within your recommendations report.
