YOUR ONESURVEY
HOME REPORT

9 The Cross
West Wemyss, Kirkcaldy
KY1 4SU

SINGLE SURVEY

Single Survey

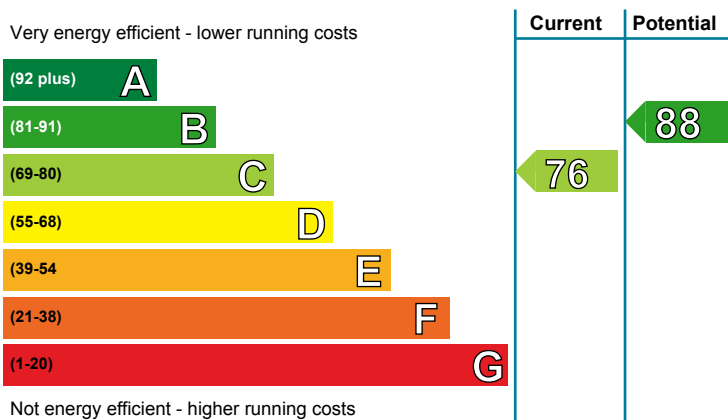
Energy Efficiency Rating

This graph shows the current efficiency of your home, taking into account both energy efficiency and fuel costs. The higher this rating, the lower your fuel bills are likely to be.

Your current rating is **band C (76)**. The average rating for EPCs in Scotland is **band D (61)**.

The potential rating shows the effect of undertaking all of the improvement measures listed within your recommendations report.
