Home Report

47 A Douglas Road Leslie KY6 3JZ

single survey

survey report on:

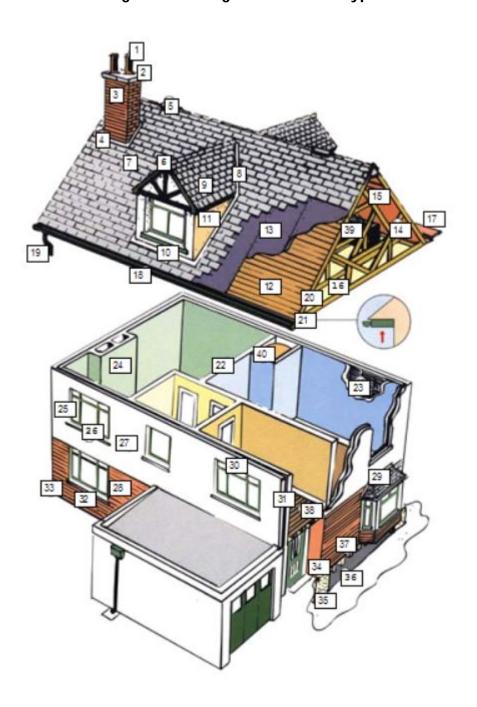
Sectional Diagram showing elements of a typical house

Chimney pots 2 Coping stone 3 Chimney head Flashing 4 Ridge ventilation 5 Ridge board Slates/tiles 8 Valley guttering 9 Dormer projection Dormer flashing 10 Dormer cheeks 11 12 Sarking Roof felt 13 Trusses 14 15 Collar 16 Insulation 17 Parapet gutter Eaves guttering 18 Rainwater downpipe 19 20 Verge boards / skews 21 Soffit boards 22 Partition wall Lath / plaster 23 24 Chimney breast 25 Window pointing Window sills 26 Rendering 27 Brickwork / pointing 28 Bay window 29 30 Lintels 31 Cavity walls / wall ties Subfloor ventilator 32 33 Damp proof course
