HOME REPORT

Energy Performance Certificate (EPC)

110 CHAPELHILL, KIRKCALDY, KY2 6PZ

SINGLE SURVEY

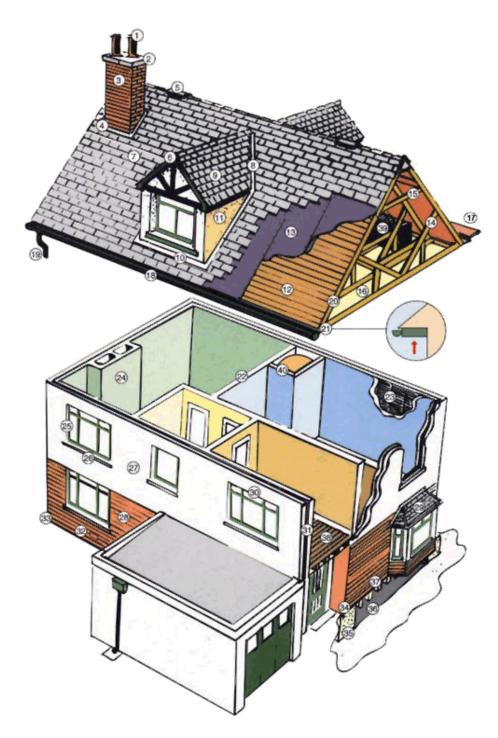
Sectional Diagram showing elements of a typical house

Reference may be made in this report to some or all of the above component parts of the property. This diagram may assist you in locating and understanding these items.

- 1) Chimney pots
- 2 Coping stone
- 3) Chimney head
- 4 Flashing
- 5) Ridge ventilation
- 6 Ridge board
- 7) Slates / tiles
- 8 Valley guttering
- 9 Dormer projection
- 10 Dormer flashing
- 11) Dormer cheeks
- 12) Sarking
- 13) Roof felt
- (14) Trusses
- 15) Collar
- 16 Insulation
- (17) Parapet gutter
- (18) Eaves guttering
- (19) Rainwater downpipe
- 20) Verge boards/skews
- 21) Soffit boards
- 22) Partition wall
- 23) Lath / plaster
- 24) Chimney breast
- (25) Window pointing
 - 6) Window sills
- 27) Rendering
- (28) Brickwork / pointing
- 29) Bay window projection
- 30 Lintels
- (31) Cavity walls / wall ties
- 32) Subfloor ventilator
- 33) Damp proof course
- 34) Base course
- (35) Foundations
- 36) Solum
- 7) Floor joists
- 8 Floorboards
- 39) Water tank
- 40 Hot water tank
