HOME REPORT

Energy Performance Certificate (EPC)

43 LONGBRAES GARDENS, KIRKCALDY, KY2 5YJ

Dwelling type: Semi-detached house
Date of assessment: 12 March 2024
Date of certificate: 14 March 2024
Total floor area: 78 m²
Primary Energy Indicator: 299 kWh/m²/year

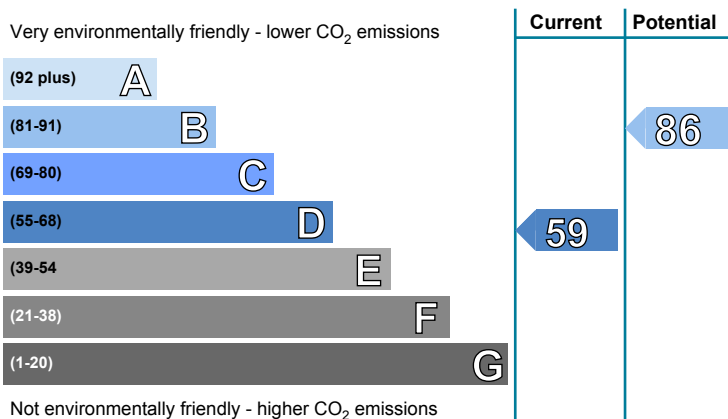
Environmental Impact (CO₂) Rating

This graph shows the effect of your home on the environment in terms of carbon dioxide (CO₂) emissions. The higher the rating, the less impact it has on the environment.

Your current rating is **band D (59)**. The average rating for EPCs in Scotland is **band D (59)**.

The potential rating shows the effect of undertaking all of the improvement measures listed within your recommendations report.
