YOUR ONESURVEY
HOME REPORT

4 Bennoch Gardens
Kirkcaldy
KY2 5JG

Single Survey

energy report

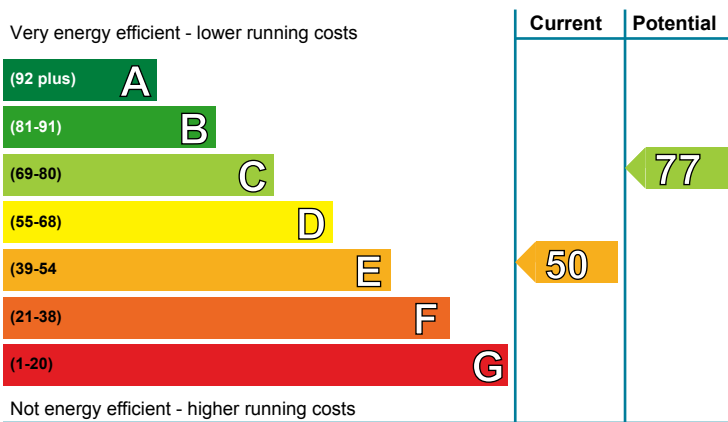
Energy Efficiency Rating

This graph shows the current efficiency of your home, taking into account both energy efficiency and fuel costs. The higher this rating, the lower your fuel bills are likely to be.

Your current rating is **band E (50)**. The average rating for EPCs in Scotland is **band D (61)**.

The potential rating shows the effect of undertaking all of the improvement measures listed within your recommendations report.

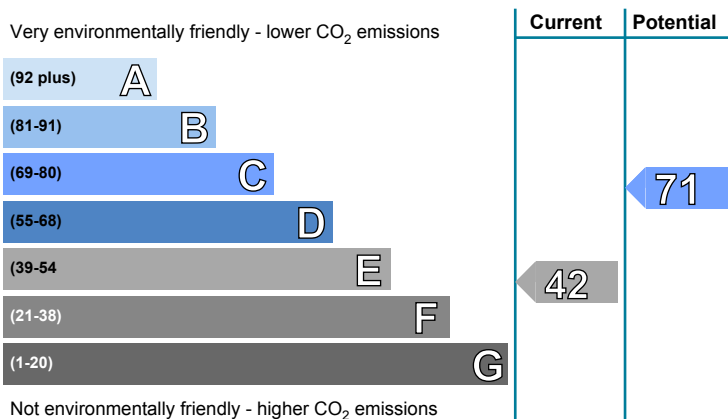
Environmental Impact (CO₂) Rating

This graph shows the effect of your home on the environment in terms of carbon dioxide (CO₂) emissions. The higher the rating, the less impact it has on the environment.
