# HOME REPORT

31 ABBOTSHALL ROAD, KIRKCALDY, KY2 5PH

Dwelling type:	Semi-detached house	Reference number:	3514-8624-6100-0062-3226
Date of assessment:	22 April 2024	Type of assessment:	RdSAP, existing dwelling
Date of certificate:	25 April 2024	Approved Organisation:	Elmhurst
Total floor area:	149 m <sup>2</sup>	Main heating and fuel:	Boiler and radiators, mains gas
Primary Energy Indicator:	376 kWh/m <sup>2</sup> /year

# Single Survey

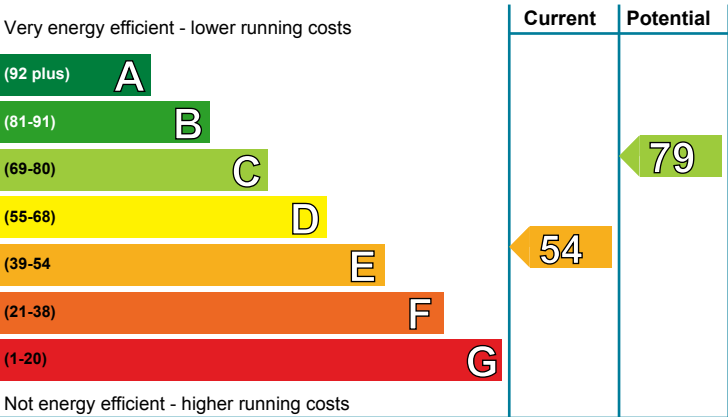
### Energy Efficiency Rating

This graph shows the current efficiency of your home, taking into account both energy efficiency and fuel costs. The higher this rating, the lower your fuel bills are likely to be.

Your current rating is **band E (54)**. The average rating for EPCs in Scotland is **band D (61)**.

The potential rating shows the effect of undertaking all of the improvement measures listed within your recommendations report.

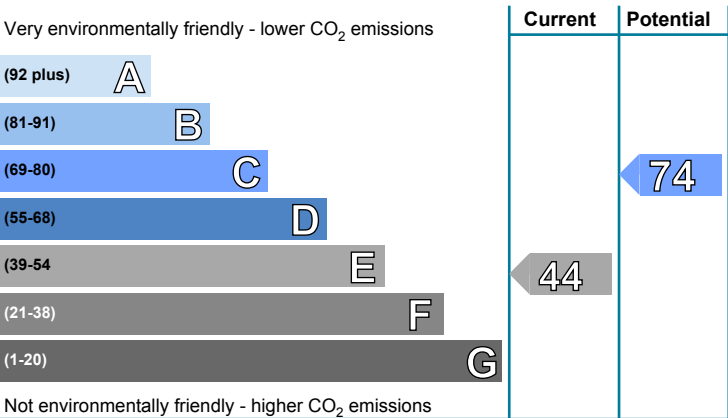
### Environmental Impact (CO<sub>2</sub>) Rating

This graph shows the effect of your home on the environment in terms of carbon dioxide (CO<sub>2</sub>) emissions. The higher the rating, the less impact it has on the environment.

Your current rating is **band E (44)**. The average rating for EPCs in Scotland is **band D (59)**.

The potential rating shows the effect of undertaking all of the improvement measures listed within your recommendations report.
