home report

**6 KINBRAE COURT
NEWPORT ON TAY
DD6 8HF**

Energy Performance Certificate (EPC)

6 KINBRAE COURT, NEWPORT ON TAY, DD6 8HF

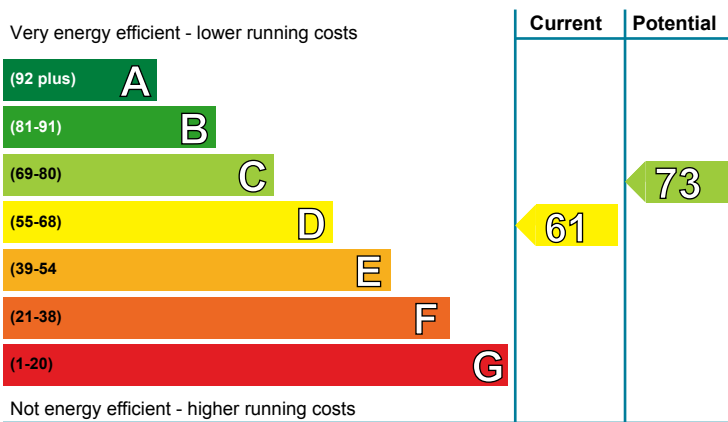
Energy Efficiency Rating

This graph shows the current efficiency of your home, taking into account both energy efficiency and fuel costs. The higher this rating, the lower your fuel bills are likely to be.

Your current rating is **band D (61)**. The average rating for EPCs in Scotland is **band D (61)**.

The potential rating shows the effect of undertaking all of the improvement measures listed within your recommendations report.

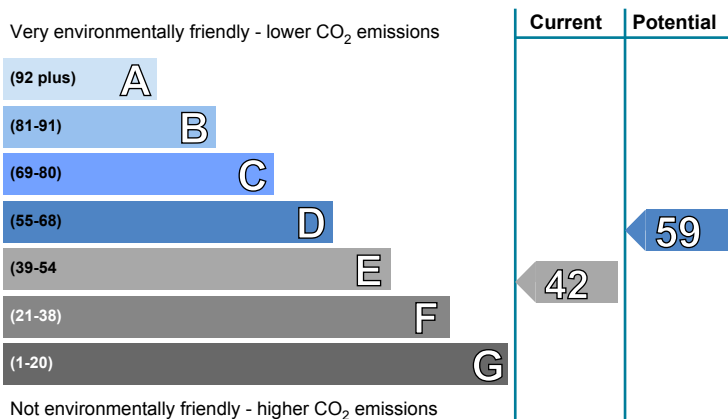
Environmental Impact (CO₂) Rating

This graph shows the effect of your home on the environment in terms of carbon dioxide (CO₂) emissions. The higher the rating, the less impact it has on the environment.

Your current rating is **band E (42)**. The average rating for EPCs in Scotland is **band D (59)**.

The potential rating shows the effect of undertaking all of the improvement measures listed within your recommendations report.

The average Scottish household produces about 6 tonnes of carbon dioxide every year. Based on this assessment, heating and lighting this home currently produces approximately 5.7 tonnes of carbon dioxide every year. Adopting recommendations in this report can reduce emissions and protect the environment. If you were to install all of these recommendations this could reduce emissions by 2.0 tonnes per year. You could reduce emissions even more by switching to renewable energy sources.
