HOME REPORT

1/2
86 BROUGHTY FERRY ROAD
DUNDEE
DD4 6JS

DM HALL
CHARTERED SURVEYORS

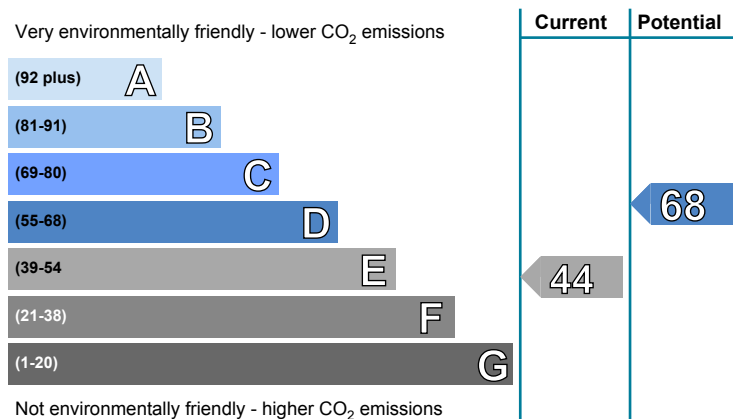
Environmental Impact (CO₂) Rating

This graph shows the effect of your home on the environment in terms of carbon dioxide (CO₂) emissions. The higher the rating, the less impact it has on the environment.

Your current rating is **band E (44)**. The average rating for EPCs in Scotland is **band D (59)**.

The potential rating shows the effect of undertaking all of the improvement measures listed within your recommendations report.
