HOME REPORT

3/2
54 BELL STREET
DUNDEE
DD1 1HF

Energy Performance Certificate (EPC)

3/2 , 54 BELL STREET, DUNDEE, DD1 1HF

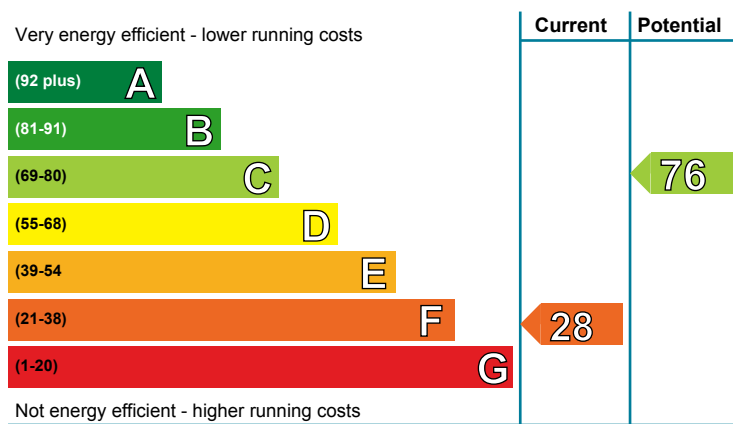
Energy Efficiency Rating

This graph shows the current efficiency of your home, taking into account both energy efficiency and fuel costs. The higher this rating, the lower your fuel bills are likely to be.

Your current rating is **band F (28)**. The average rating for EPCs in Scotland is **band D (61)**.

The potential rating shows the effect of undertaking all of the improvement measures listed within your recommendations report.

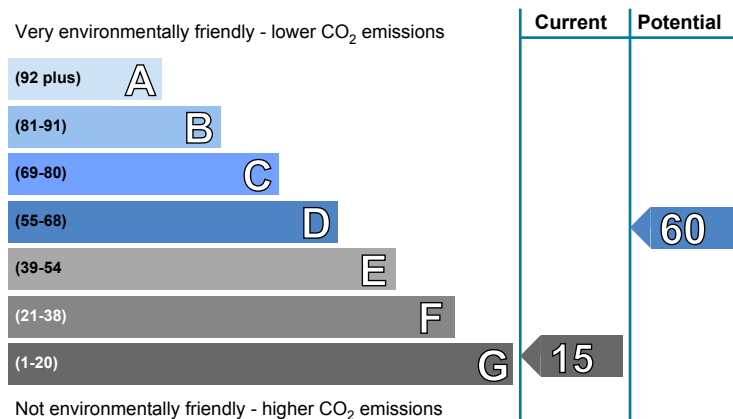
Environmental Impact (CO₂) Rating

This graph shows the effect of your home on the environment in terms of carbon dioxide (CO₂) emissions. The higher the rating, the less impact it has on the environment.

Your current rating is **band G (15)**. The average rating for EPCs in Scotland is **band D (59)**.

The potential rating shows the effect of undertaking all of the improvement measures listed within your recommendations report.

The average Scottish household produces about 6 tonnes of carbon dioxide every year. Based on this assessment, heating and lighting this home currently produces approximately 12 tonnes of carbon dioxide every year. Adopting recommendations in this report can reduce emissions and protect the environment. If you were to install all of these recommendations this could reduce emissions by 8.1 tonnes per year. You could reduce emissions even more by switching to renewable energy sources.
