HOME REPORT

107 ORCHARD WAY
INCHTURE
PERTH
PH14 9RU

ENERGY PERFORMANCE CERTIFICATE

107 ORCHARD WAY, INCHTURE, PERTH, PH14 9RU

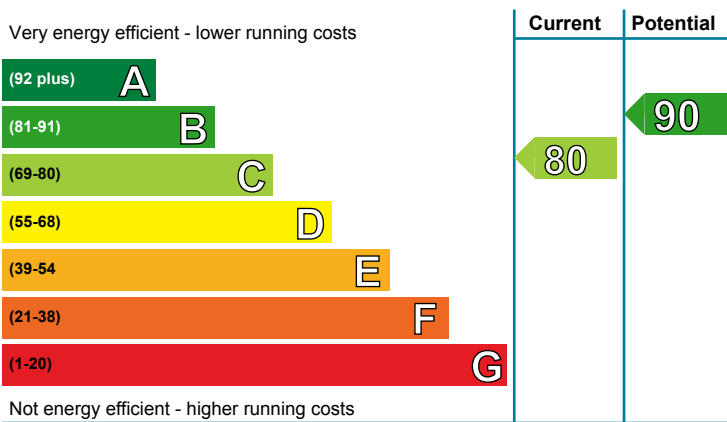
Energy Efficiency Rating

This graph shows the current efficiency of your home, taking into account both energy efficiency and fuel costs. The higher this rating, the lower your fuel bills are likely to be.

Your current rating is **band C (80)**. The average rating for EPCs in Scotland is **band D (61)**.

The potential rating shows the effect of undertaking all of the improvement measures listed within your recommendations report.
